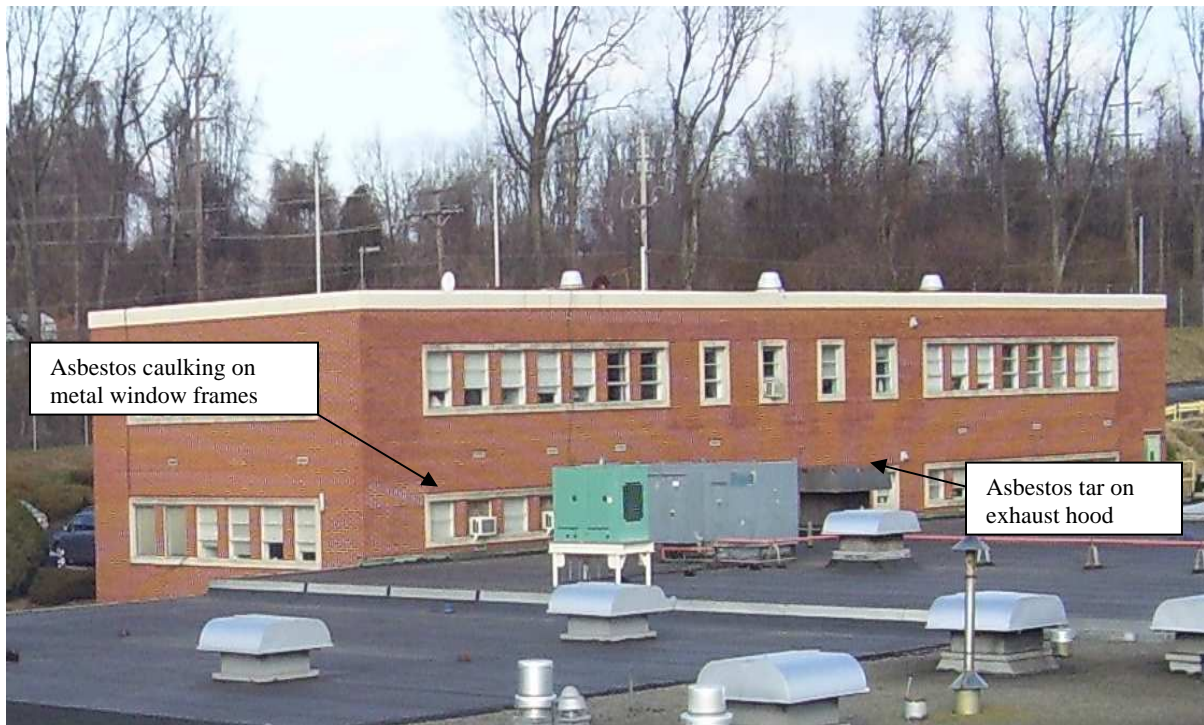
**Photo 1**

View of south and west sides of Office Building. Roof of Central Unit in foreground. Tar covered exhaust hood in center of photo.

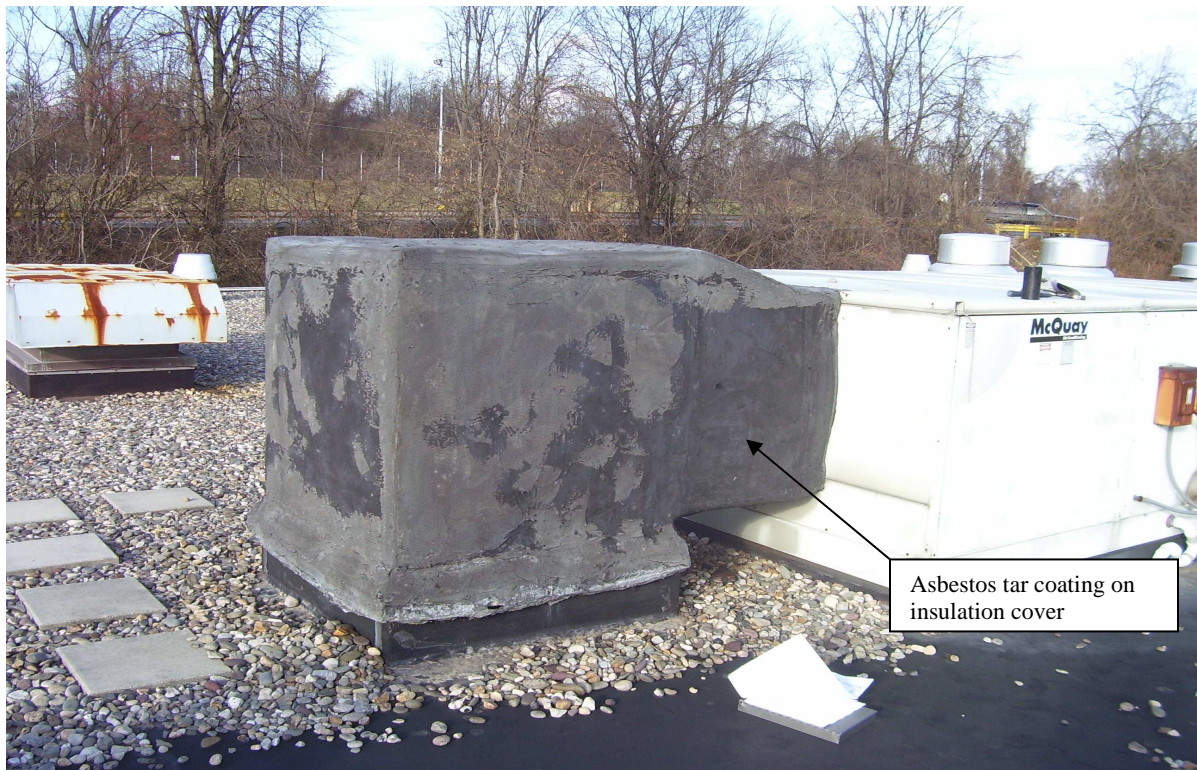
**Photo 2**

View of duct work on roof of Building 12.

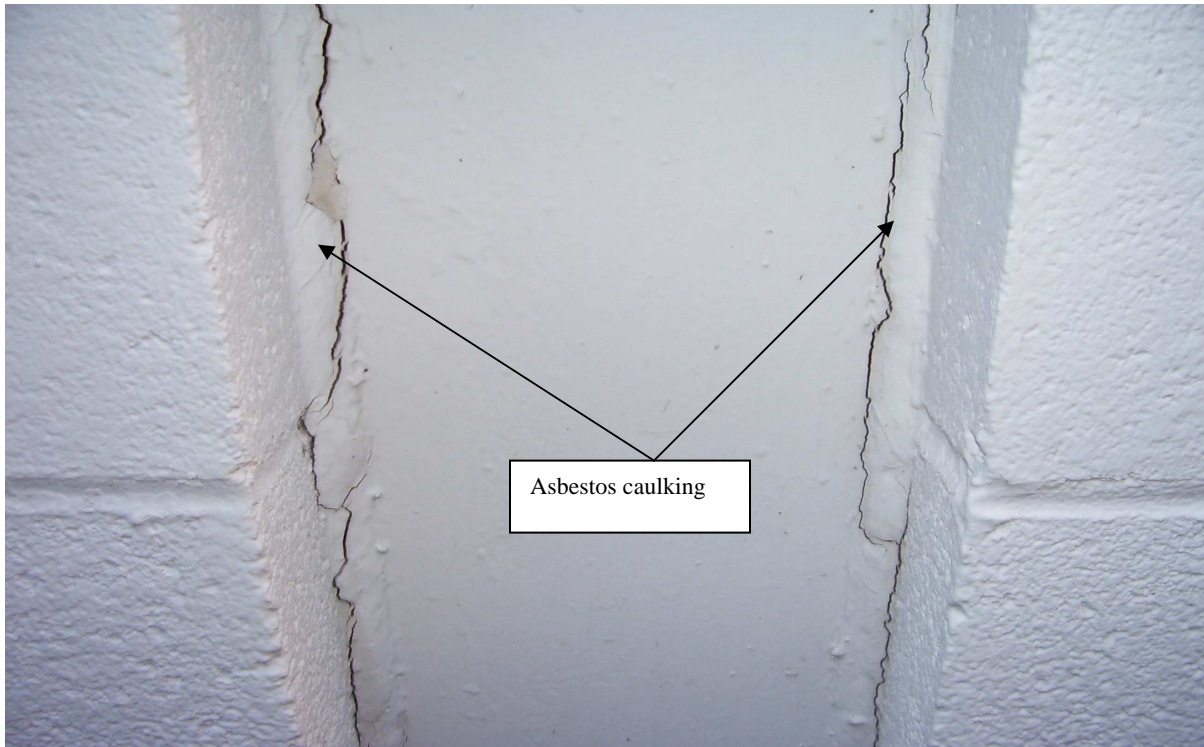
**Photo 3**

Asbestos caulking on exterior wide flange columns. North side of Building 50.

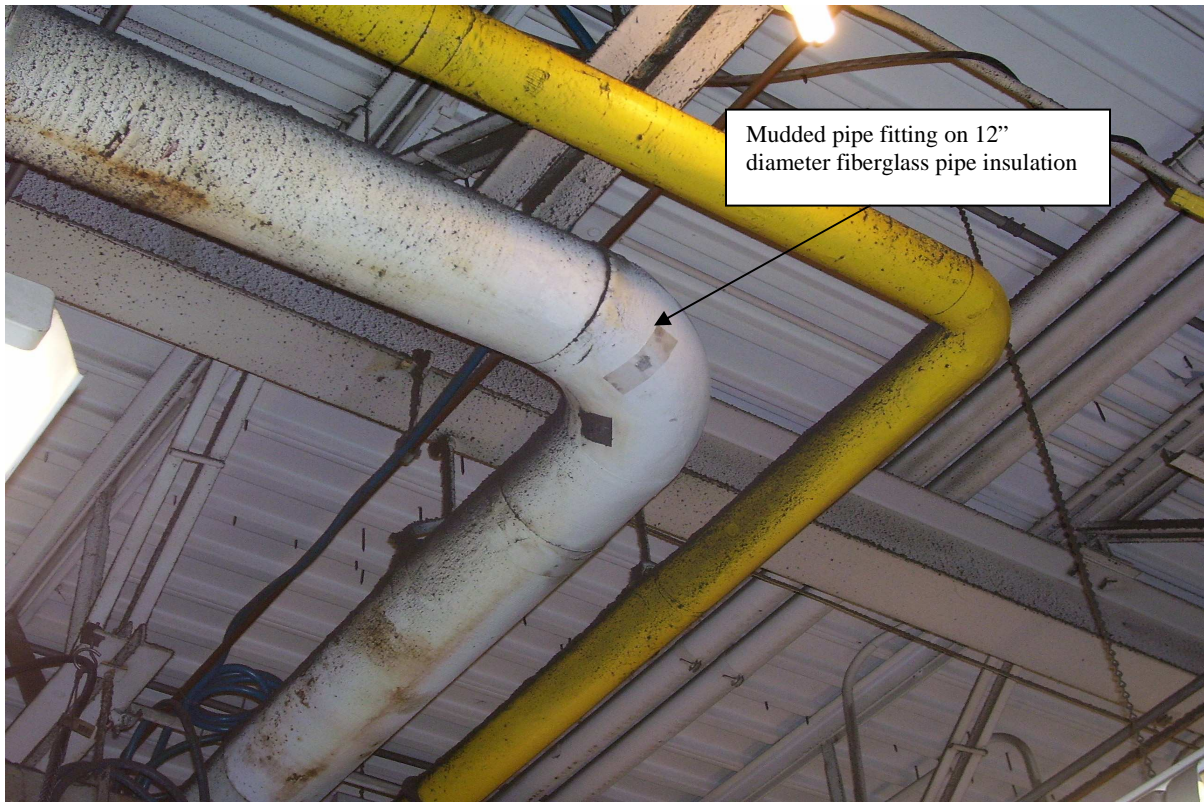
**Photo 4**

Mudded pipe fitting. Center of Building 7.

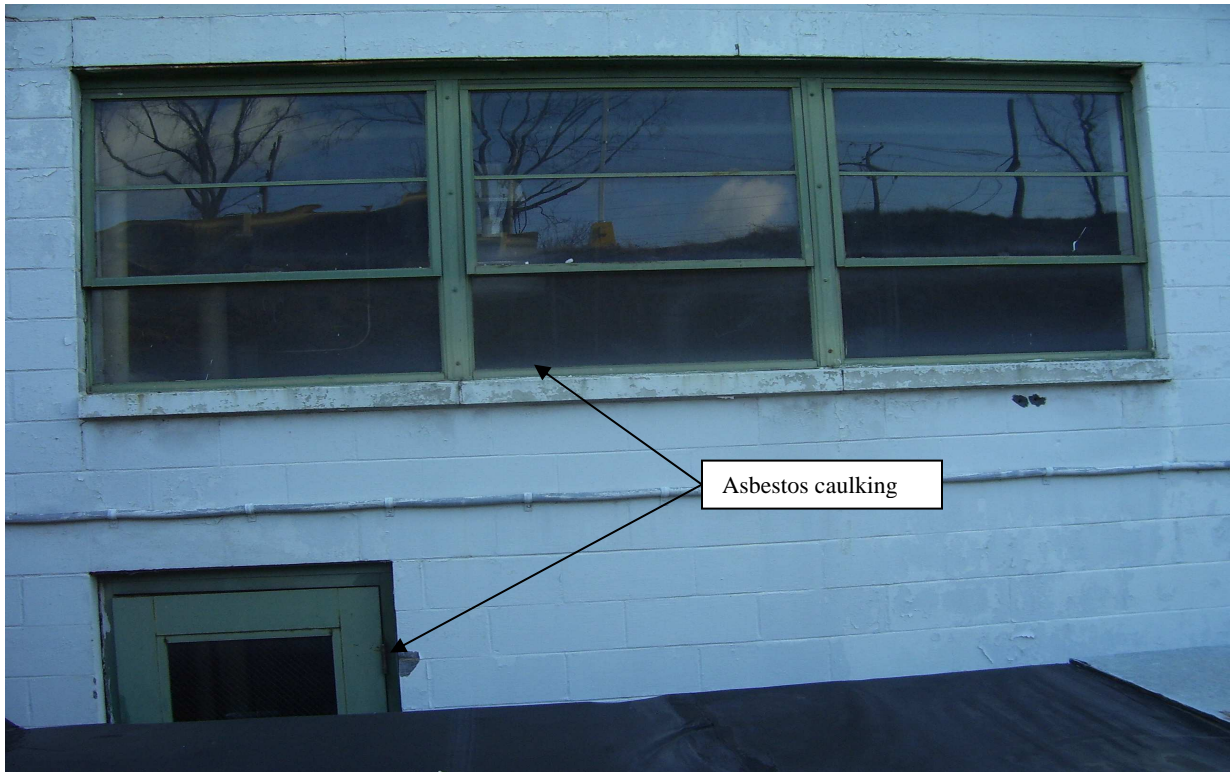
**Photo 5**

Door and window frames with asbestos caulking. North side of Building 9.

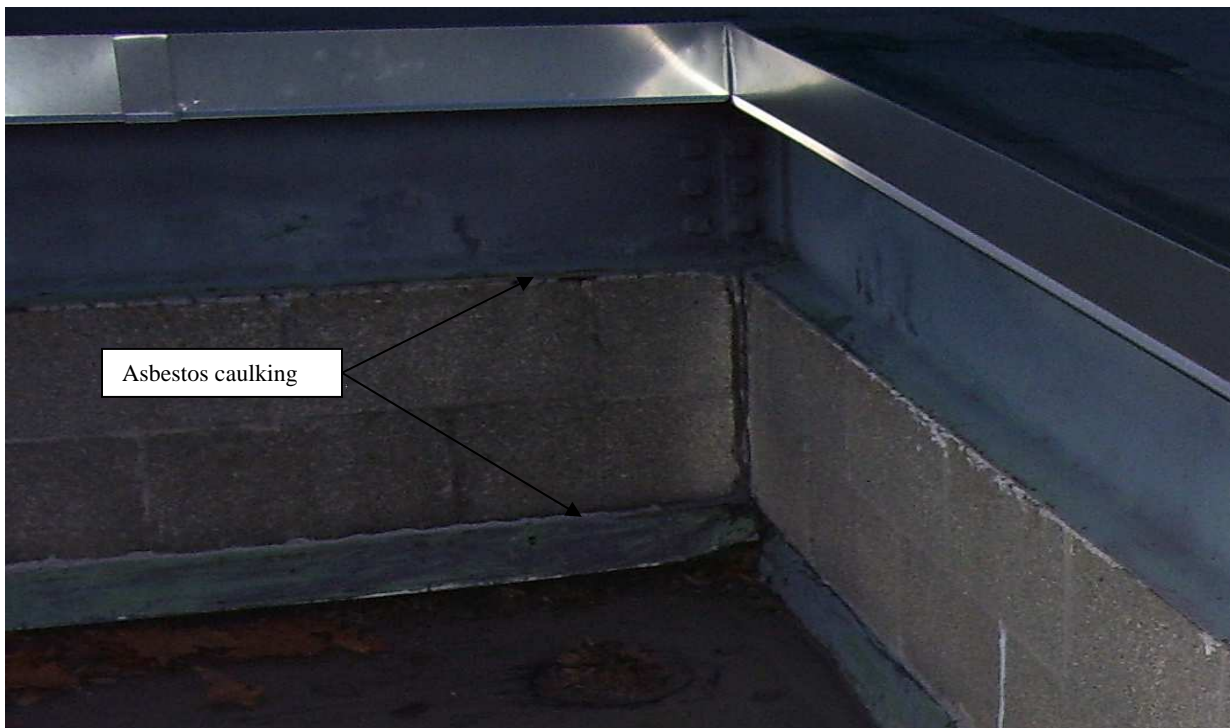
**Photo 6**

Asbestos caulking on copper flashing and at base of wide flange beam. Lower roof on south side of Building 50.
